# Manhole Inspection Summary

Manhole # S37Q\_\_032MH

Insp Date: **4/2/09 9:27 AM**

**Location** Address: **1157 RIVERSIDE AV**

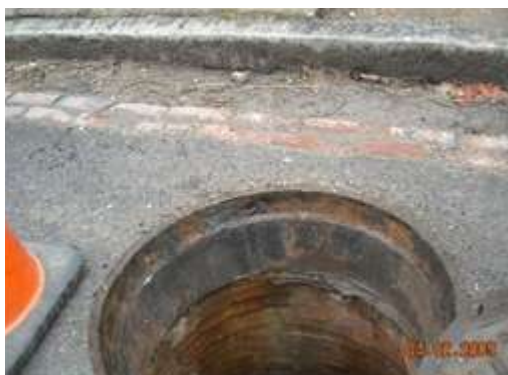
MISC.

Subject To Ponding: **Sheeting**

INFLOW EVIDENCE FROM SHEETING

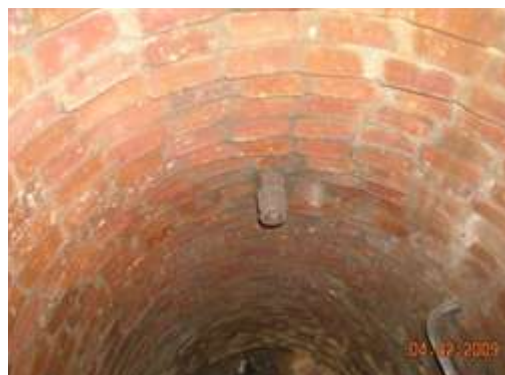
MISC.

PIPE INTRUSION @ 6 OCLOCK CORBEL

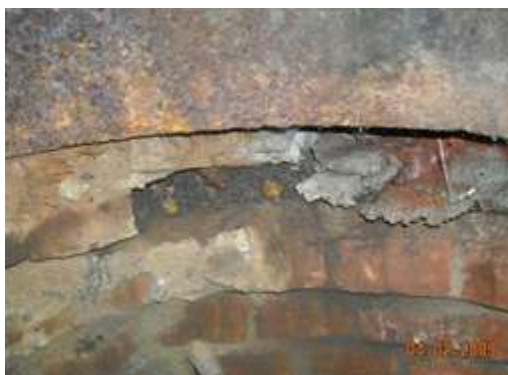
Defect 2

Condition: ☐ Sound ☐ Cracked ☐ Root Intrusion ☐ Loose Brick ☒ **Deteriorated**

DETERIORATED CHIMNEY

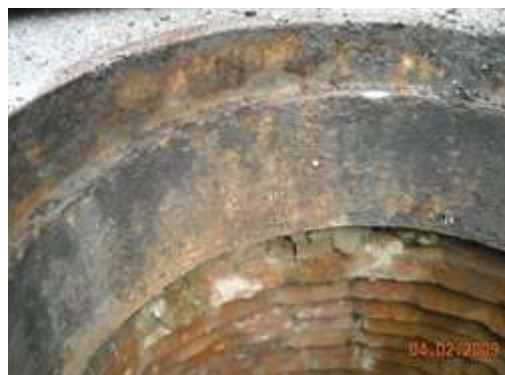
Defect 1

☒ **Leaks**

FRAME LEAKS
